Manhole Inspection Summary

Manhole # S05AA2008MH

Insp Date: **8/17/06 12:00 AM**

Location Address: **3109 PARKINGTON AVE**

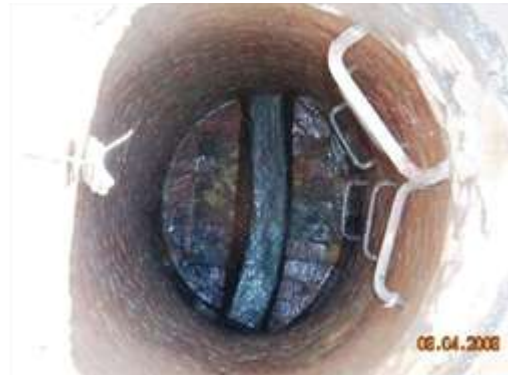
Top View

Corroded steps. Evidence of surcharge - Bench debris.

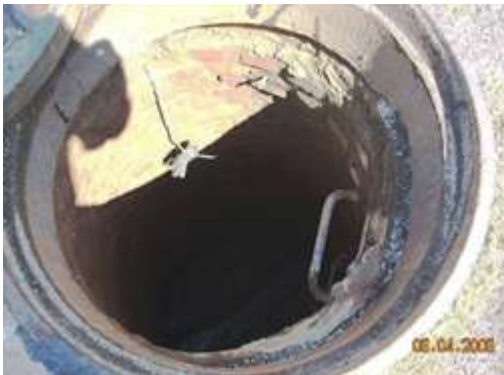
Defect

Frame leaks. Frame offset. Adjustment deterioration and infiltration. Barrel infiltration - other side.

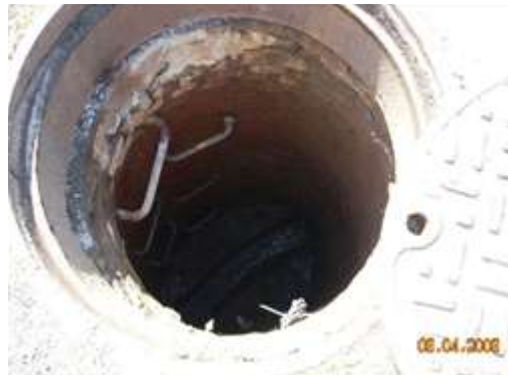
Defect

Frame leaks. Frame offset. Adjustment deterioration and infiltration. Barrel infiltration.

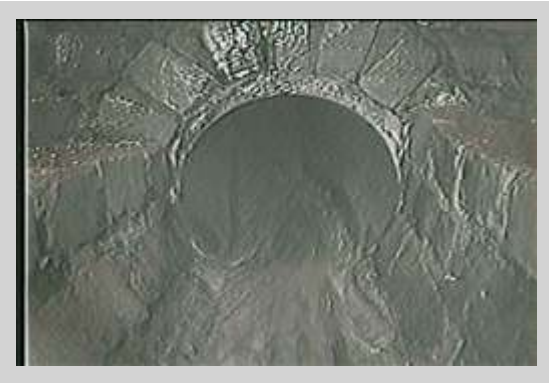
10 in. Circular Gravity Sewer Pipe Out @ 12 O'Clock

Pipe Material: **Clay** ☐ Pipe Lined

Invert Depth: **12.23** (ft.) Flow Characteristics: **Fast**

Deposits: ☒ None ☐ Mud ☐ Sludge ☐ Debris ☐ Grease

Infiltration: **None** Pipe Seal Cond: **Unknown**

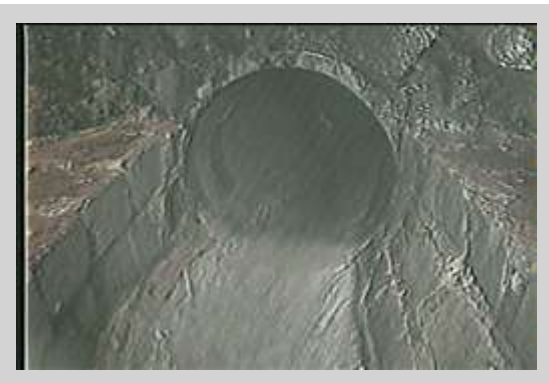
10 in. Circular Gravity Sewer Pipe In @ 7 O'Clock

Pipe Material: **Unknown** ☐ Pipe Lined

Invert Depth: **11.98** (ft.) Flow Characteristics: **Fast**

Deposits: ☒ None ☐ Mud ☐ Sludge ☐ Debris ☐ Grease

Infiltration: **None** Pipe Seal Cond: **Unknown**
